Manhole Inspection Summary

Manhole # S33S__012MH

Inspection ☐ Is Incomplete Rating: **4) Poor**

Location Address: **100 w ostend st**

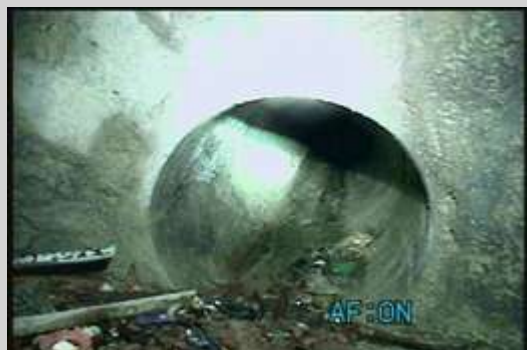
12 O'Clock Outflow

8 in. Circular Gravity Sewer
Pipe Out @ 12 O'Clock

Pipe Material: **Clay** ☐ Pipe Lined

Infiltration: **None** Pipe Seal Cond: **Unknown**
